# Thermography Report

Customer: John Smith

Thermography date:	21/06/05
Outdoor temperature:	25 °C
Indoor temperature:	20 °C
Temp diff In-Out At:	5 °C

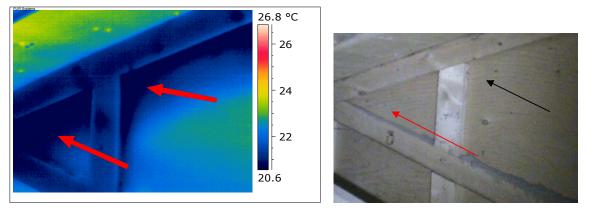
Picture 1. Captured at: (attic suite 12

Comment: This image shows moisture entering the attic space.

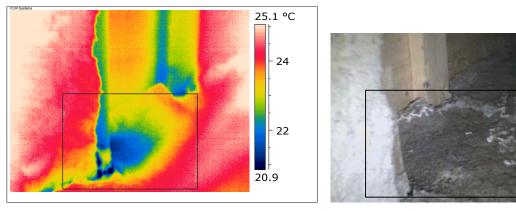
### Picture 2. Captured at: (atic suite 12

Comment: This image also shows moisture entering the attic space and saturating the insulation.

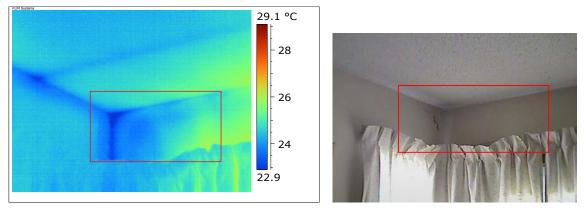
Picture 3. Captured at: (N/E Corner Suite 9

Comment: This image shows moisture entering the wall cavity.

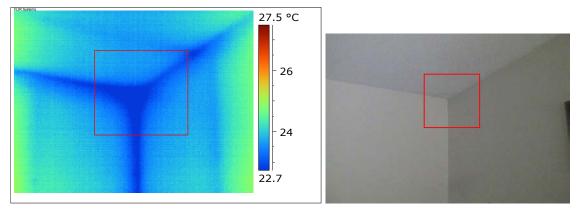
# Picture 4. Captured at: (S/E Corner Suite 9)

Comment: Again, there is moisture entering the wall cavity.

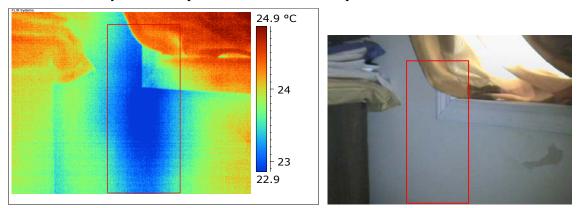
# Picture 5. Captured at: (East Bedroom S.9 M.F)

Comment: Moisture is leaking in around this window and is being wicked up by the insulation in the wall.

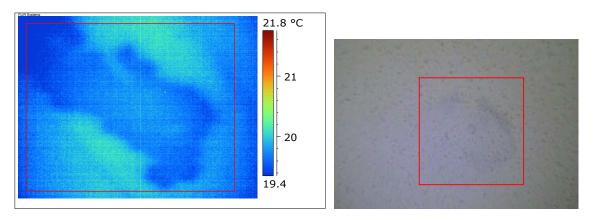
### Picture 6. Captured at: (Suite 15 East hall ceiling)

Comment: Water is leaking into the attic and is causing noticeable damage to the stippled ceiling.

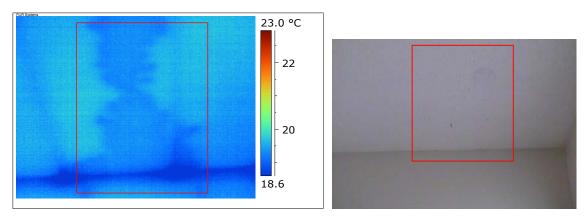
## Picture 7. Captured at: (Suite 15 East hall ceiling/wall)

Comment: This image is a continuation of the previous image. This image is also showing the moisture entering the wall cavity from the attic.

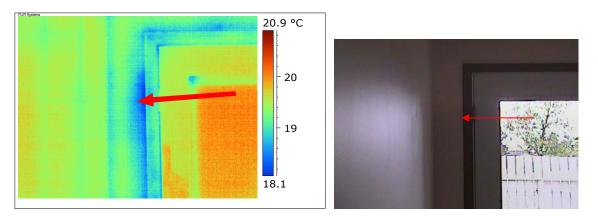
#### Picture 8. Captured at: (Suite 15 Patio Door)

Comment: There is moisture or air infiltrating into this wall from around the patio door.

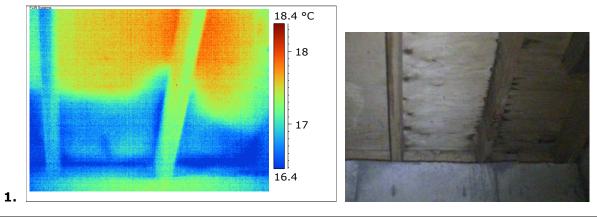
# Picture 9. Captured at: (Suite 15 Basement Sub-Floor)

Comment: The water that was entering the wall above has done noticeable damage to the sub-floor below.

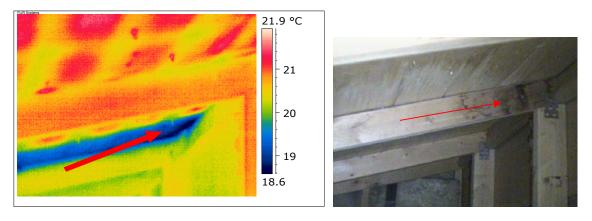
#### Picture 10. Captured at: (Suite 15 Attic)

Comment: Water is entering this attic and is prematurely rotting the rafters.

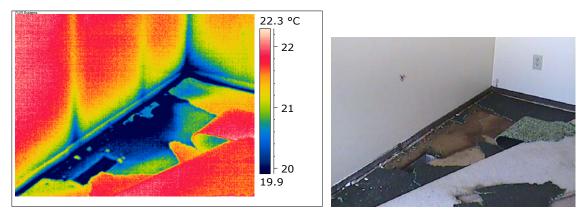
## Picture 11. Captured at: (Suite 16 West Wall)

Comment: Major damage is evident here due to water infiltration.

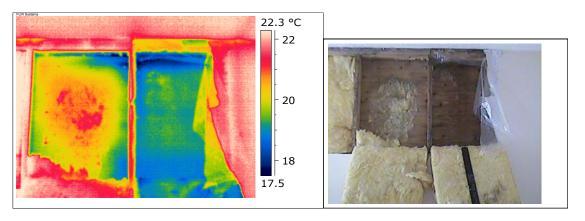
# Picture 12. Captured at: (Suite 16 West Wall)

Comment: Again major water damage and the onset of mold growth.
